BUILDING DIAGNOSTICS REPORT

THERMOGRAPHIC INSPECTIONS

Inspected By: Thermograpros

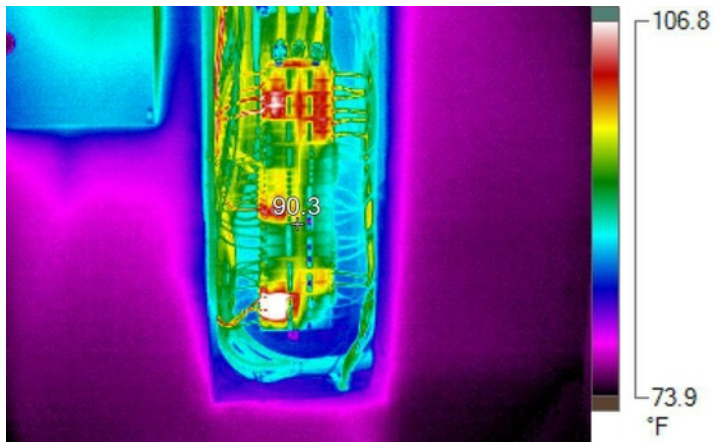
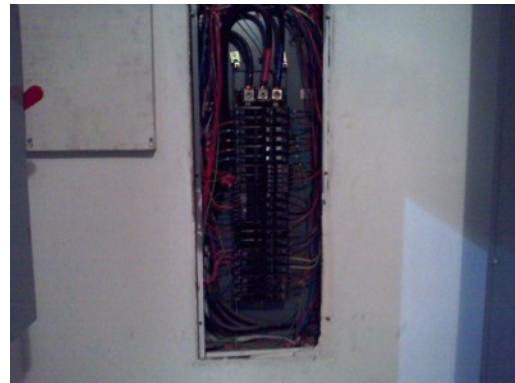
IR000658.IS2

Inspection Date:	1/22/2013 12:48:15 PM	Location	Equipment room
Equipment	Service panel	Equipment Name:	Panel 1
Ambient Air Temp:	68.0 °F	Wind Speed	0
Load (%)	No deliberate load imposed	Max Rated Load:	0
Exception Temperature:	0	Potential Problem	None
Recommended Action	No action	Repair Priority:	0
Emissivity:	0.95	Reflected Temperature:	68.0 °F
Camera Manufacturer	Fluke Thermography	Camera:	Ti32-10020374 (60Hz)

Name	Temperature	Emissivity	Background
SEP	90.3°F	0.95	68.0°F

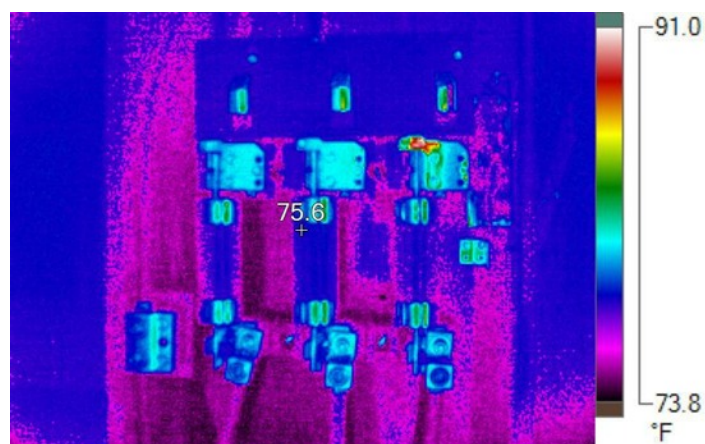
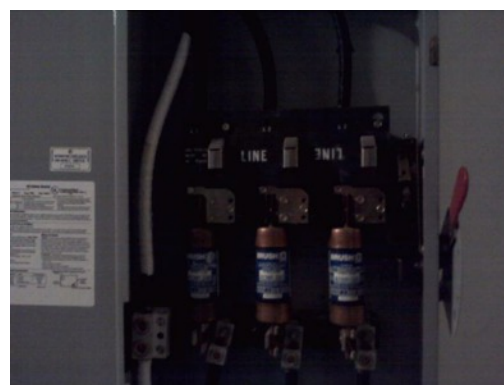
IR000659.IS2

Inspection Date:	1/22/2013 12:48:58 PM	Location	Equipment room
Equipment	Disconnect	Equipment Name:	Panel 2
Ambient Air Temp:	68.0 °F	Wind Speed	0
Load (%)	No deliberate load imposed	Max Rated Load:	0
Exception Temperature:	0	Potential Problem	None
Recommended Action	No action	Repair Priority:	0
Emissivity:	0.95	Reflected Temperature:	68.0 °F
Camera Manufacturer	Fluke Thermography	Camera:	Ti32-10020374 (60Hz)

Name	Temperature	Emissivity	Background
Disco	75.6°F	0.95	68.0°F

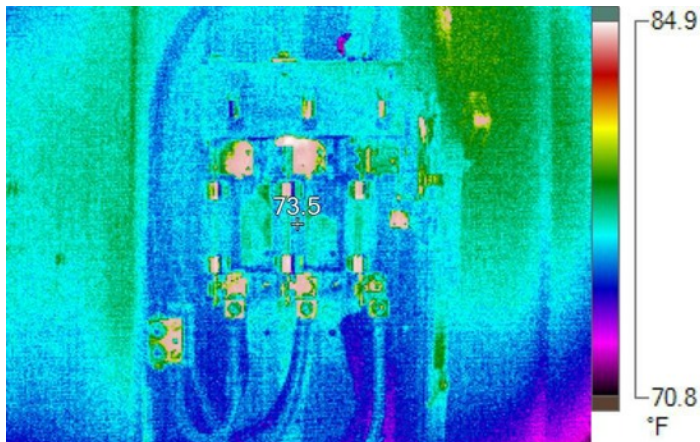
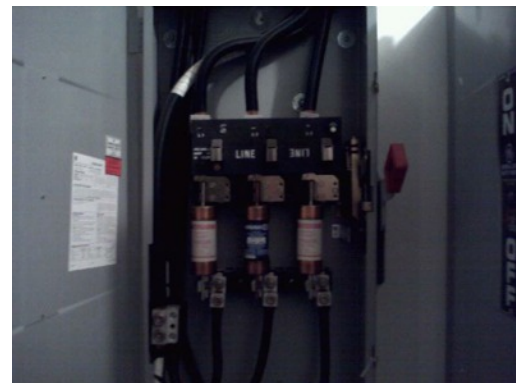
IR000660.IS2

Inspection Date:	1/22/2013 12:54:11 PM	Location	Equipment room
Equipment	Disconnect	Equipment Name:	Panel 3
Ambient Air Temp:	68.0 °F	Wind Speed	0
Load (%)	No deliberate load imposed	Max Rated Load:	0
Exception Temperature:	0	Potential Problem	None
Recommended Action	No action	Repair Priority:	0
Emissivity:	0.95	Reflected Temperature:	68.0 °F
Camera Manufacturer	Fluke Thermography	Camera:	Ti32-10020374 (60Hz)

Name	Temperature	Emissivity	Background
Disco	73.5°F	0.95	68.0°F

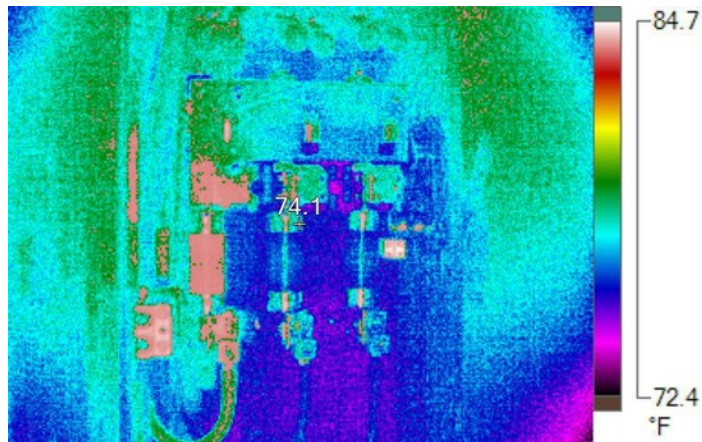
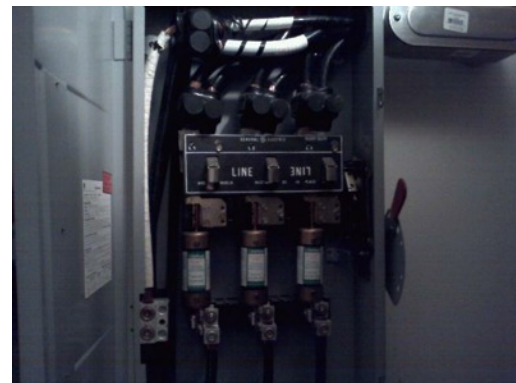
IR000661.IS2

Inspection Date:	1/22/2013 12:54:36 PM	Location	Equipment room
Equipment	Disconnect	Equipment Name:	Panel 4
Ambient Air Temp:	68.0 °F	Wind Speed	0
Load (%)	No deliberate load imposed	Max Rated Load:	0
Exception Temperature:	0	Potential Problem	None
Recommended Action	No action	Repair Priority:	0
Emissivity:	0.95	Reflected Temperature:	68.0 °F
Camera Manufacturer	Fluke Thermography	Camera:	Ti32-10020374 (60Hz)

Name	Temperature	Emissivity	Background
disco	74.1°F	0.95	68.0°F

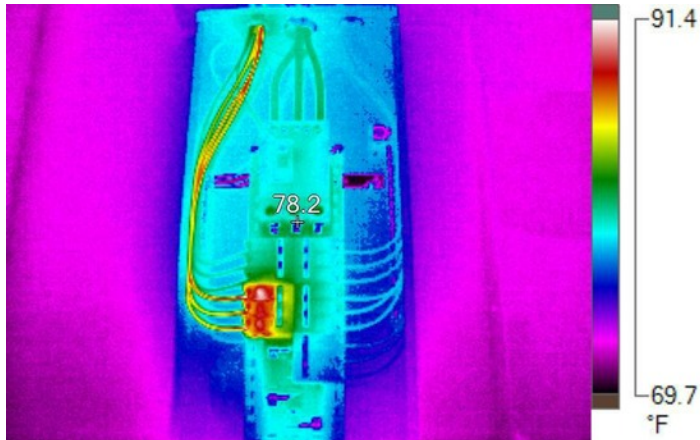
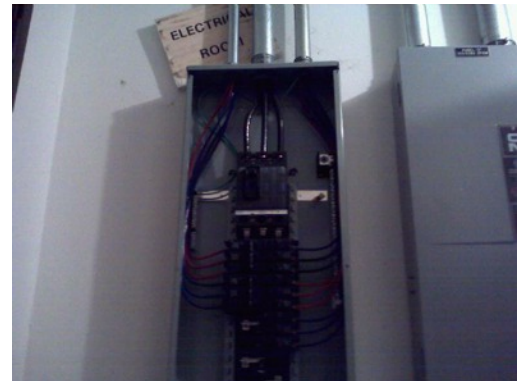
IR000664.IS2

Inspection Date:	1/22/2013 12:56:53 PM	Location	Equipment room
Equipment	Service panel	Equipment Name:	Panel 5
Ambient Air Temp:	68.0 °F	Wind Speed	0
Load (%)	No deliberate load imposed	Max Rated Load:	0
Exception Temperature:	0	Potential Problem	None
Recommended Action	No action	Repair Priority:	0
Emissivity:	0.95	Reflected Temperature:	68.0 °F
Camera Manufacturer	Fluke Thermography	Camera:	Ti32-10020374 (60Hz)

Name	Temperature	Emissivity	Background
SEP	78.2°F	0.95	68.0°F

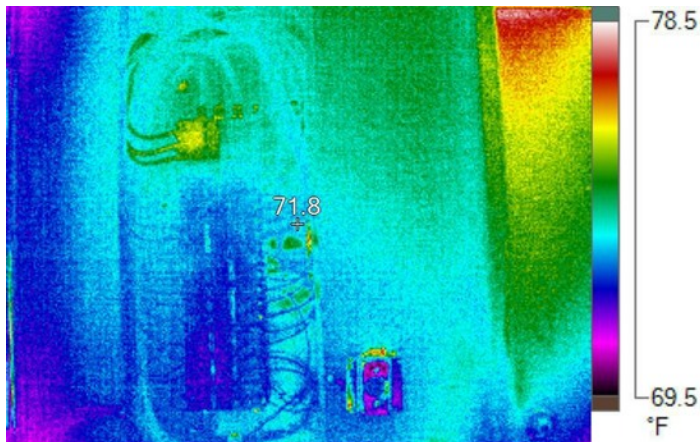
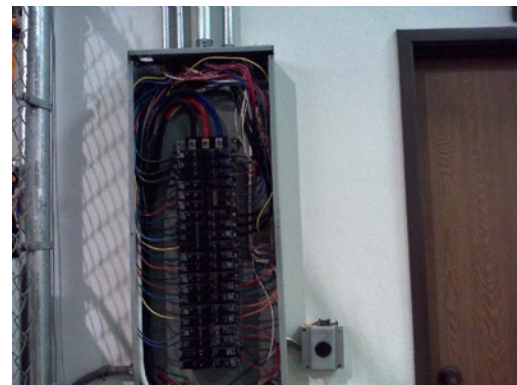
IR000665.IS2

Inspection Date:	1/22/2013 1:04:11 PM	Location	Interior
Equipment	Service panel	Equipment Name:	Panel 6
Ambient Air Temp:	68.0 °F	Wind Speed	0
Load (%)	No deliberate load imposed	Max Rated Load:	0
Exception Temperature:	0	Potential Problem	None
Recommended Action	No action	Repair Priority:	0
Emissivity:	0.95	Reflected Temperature:	68.0 °F
Camera Manufacturer	Fluke Thermography	Camera:	Ti32-10020374 (60Hz)

Name	Temperature	Emissivity	Background
SEP	71.8°F	0.95	68.0°F

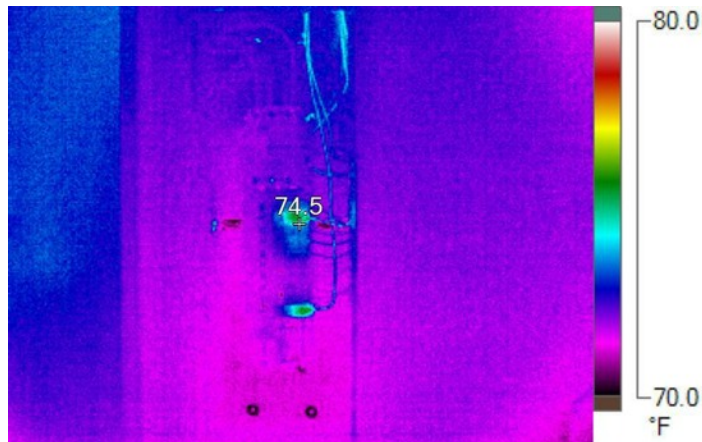
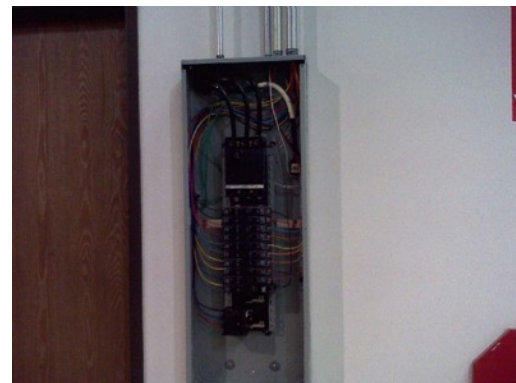
IR000666.IS2

Inspection Date:	1/22/2013 1:05:06 PM	Location	Interior
Equipment	Interior	Equipment Name:	Panel 7
Ambient Air Temp:	68.0 °F	Wind Speed	0
Load (%)	No deliberate load imposed	Max Rated Load:	0
Exception Temperature:	0	Potential Problem	None
Recommended Action	No action	Repair Priority:	0
Emissivity:	0.95	Reflected Temperature:	68.0 °F
Camera Manufacturer	Fluke Thermography	Camera:	Ti32-10020374 (60Hz)

Name	Temperature	Emissivity	Background
SEP	74.5°F	0.95	68.0°F

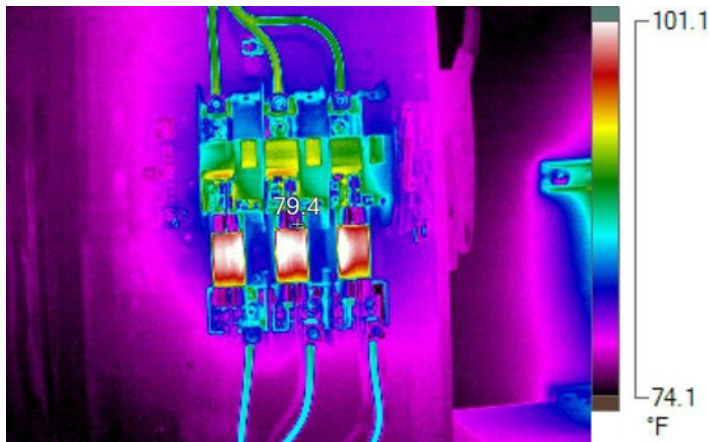
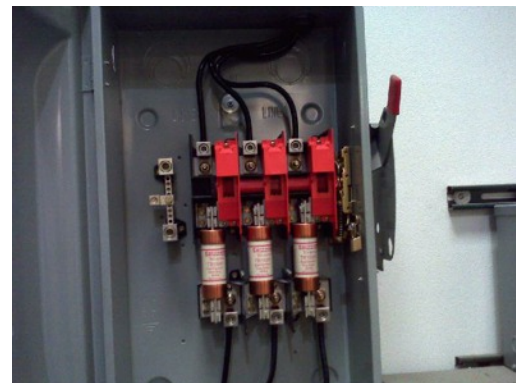
IR000667.IS2

Inspection Date:	1/22/2013 1:10:18 PM	Location	Interior
Equipment	Disconnect	Equipment Name:	Panel 8
Ambient Air Temp:	68.0 °F	Wind Speed	0
Load (%)	No deliberate load imposed	Max Rated Load:	0
Exception Temperature:	0	Potential Problem	None
Recommended Action	No action	Repair Priority:	0
Emissivity:	0.95	Reflected Temperature:	68.0 °F
Camera Manufacturer	Fluke Thermography	Camera:	Ti32-10020374 (60Hz)

Name	Temperature	Emissivity	Background
Disco	79.4°F	0.95	68.0°F

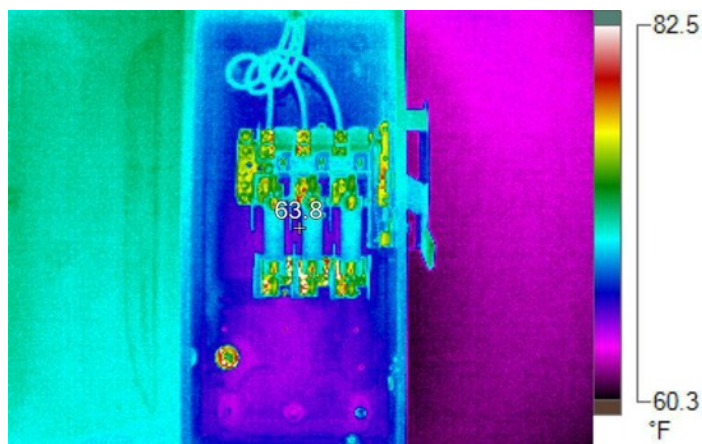
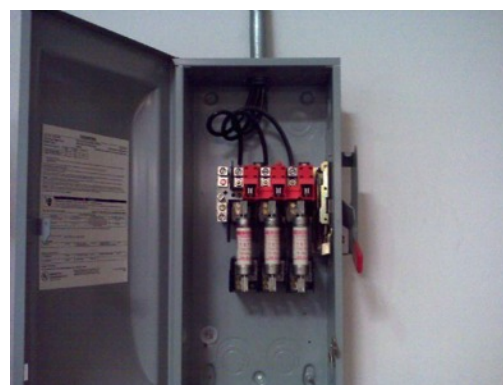
IR000668.IS2

Inspection Date:	1/22/2013 1:16:08 PM	Location	Interior
Equipment	Disconnect	Equipment Name:	Panel 9
Ambient Air Temp:	68.0 °F	Wind Speed	0
Load (%)	No deliberate load imposed	Max Rated Load:	0
Exception Temperature:	0	Potential Problem	None
Recommended Action	No action	Repair Priority:	0
Emissivity:	0.95	Reflected Temperature:	68.0 °F
Camera Manufacturer	Fluke Thermography	Camera:	Ti32-10020374 (60Hz)

Name	Temperature	Emissivity	Background
Disco	63.8°F	0.95	68.0°F

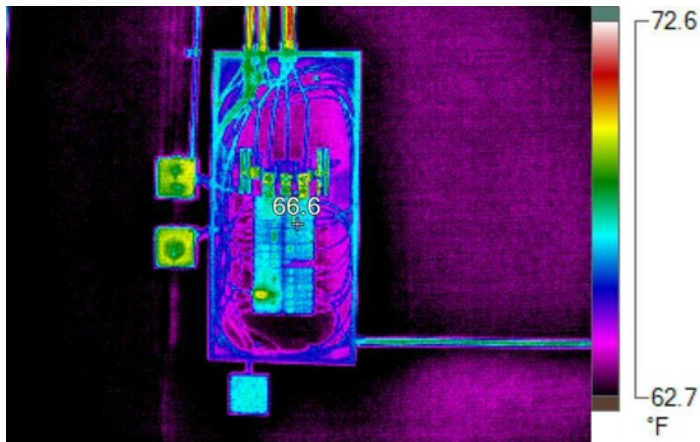
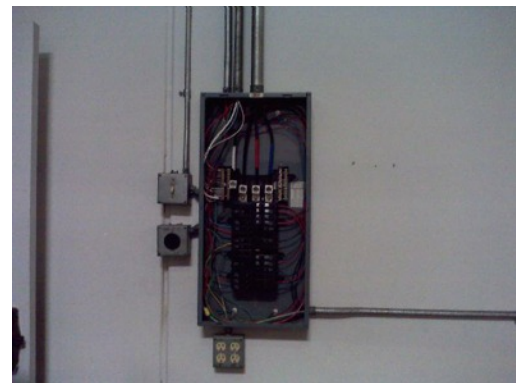
IR000669.IS2

Inspection Date:	1/22/2013 1:16:39 PM	Location	Interior
Equipment	Service panel	Equipment Name:	Panel 10
Ambient Air Temp:	68.0 °F	Wind Speed	0
Load (%)	No deliberate load imposed	Max Rated Load:	0
Exception Temperature:	0	Potential Problem	None
Recommended Action	No action	Repair Priority:	0
Emissivity:	0.95	Reflected Temperature:	68.0 °F
Camera Manufacturer	Fluke Thermography	Camera:	Ti32-10020374 (60Hz)

Name	Temperature	Emissivity	Background
SEP	66.6°F	0.95	68.0°F

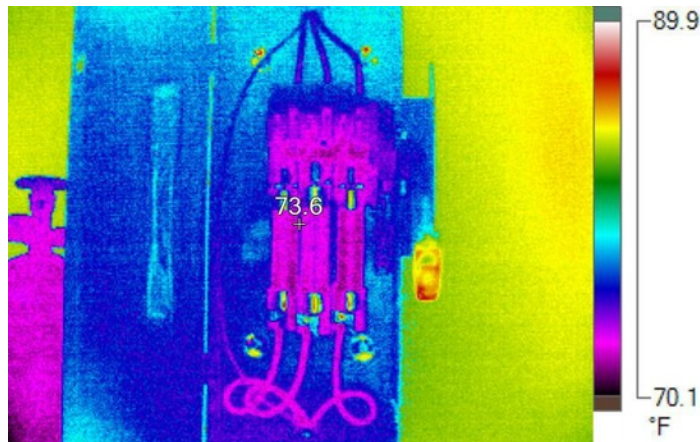
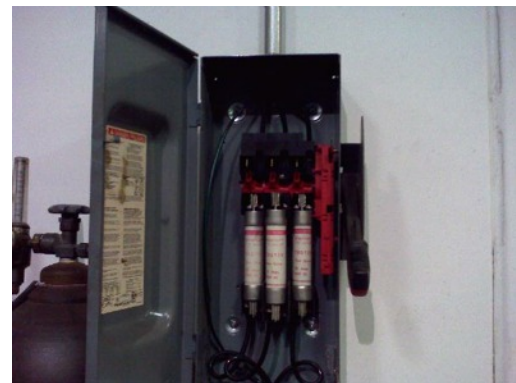
IR000670.IS2

Inspection Date:	1/22/2013 1:21:39 PM	Location	Interior mach.
Equipment	Disconnect	Equipment Name:	Panel 11
Ambient Air Temp:	68.0 °F	Wind Speed	0
Load (%)	No deliberate load imposed	Max Rated Load:	0
Exception Temperature:	0	Potential Problem	None
Recommended Action	No action	Repair Priority:	0
Emissivity:	0.95	Reflected Temperature:	68.0 °F
Camera Manufacturer	Fluke Thermography	Camera:	Ti32-10020374 (60Hz)

Name	Temperature	Emissivity	Background
Disco	73.6°F	0.95	68.0°F

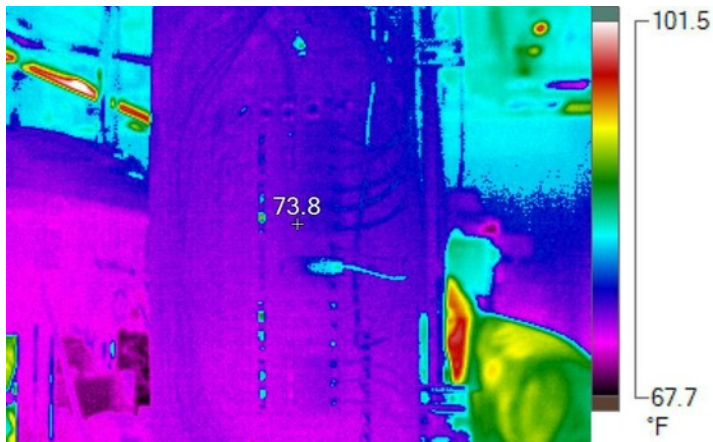
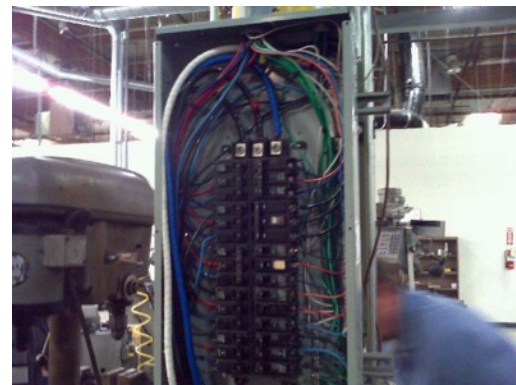
IR000671.IS2

Inspection Date:	1/22/2013 1:26:55 PM	Location	Interior mach.
Equipment	Service panel	Equipment Name:	Panel 12
Ambient Air Temp:	68.0 °F	Wind Speed	0
Load (%)	No deliberate load imposed	Max Rated Load:	0
Exception Temperature:	0	Potential Problem	None
Recommended Action	No action	Repair Priority:	0
Emissivity:	0.95	Reflected Temperature:	68.0 °F
Camera Manufacturer	Fluke Thermography	Camera:	Ti32-10020374 (60Hz)

Name	Temperature	Emissivity	Background
SEP	73.8°F	0.95	68.0°F

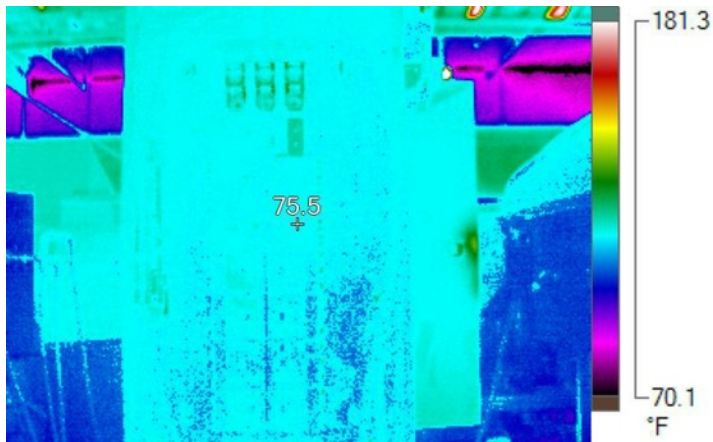
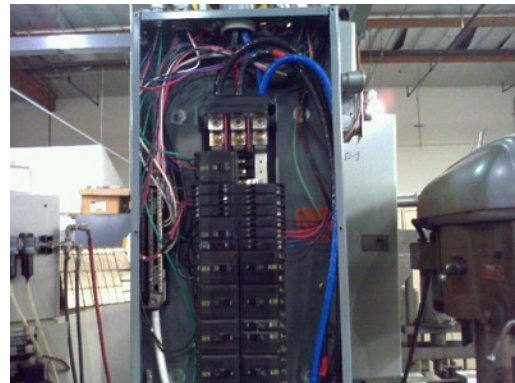
IR000672.IS2

Inspection Date:	1/22/2013 1:27:31 PM	Location	Interior mach.
Equipment	Service panel	Equipment Name:	Panel 13
Ambient Air Temp:	68.0 °F	Wind Speed	0
Load (%)	No deliberate load imposed	Max Rated Load:	0
Exception Temperature:	0	Potential Problem	None
Recommended Action	No action	Repair Priority:	0
Emissivity:	0.95	Reflected Temperature:	68.0 °F
Camera Manufacturer	Fluke Thermography	Camera:	Ti32-10020374 (60Hz)

Name	Temperature	Emissivity	Background
SEP	75.5°F	0.95	68.0°F

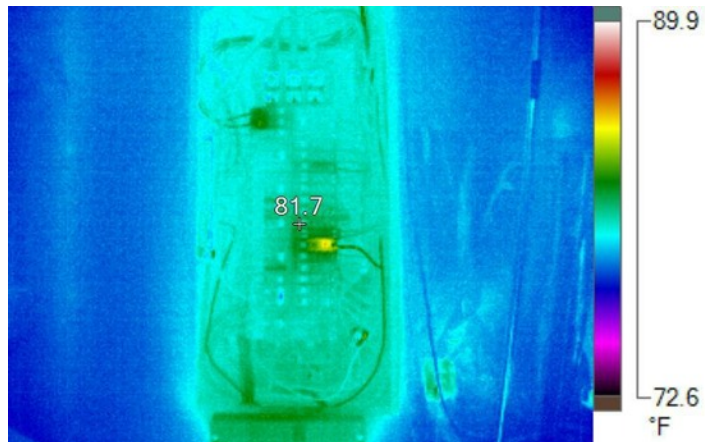
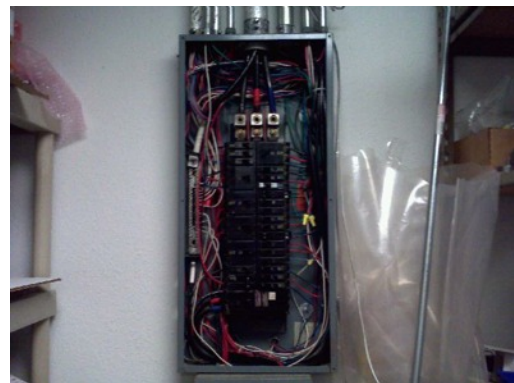
IR000673.IS2

Inspection Date:	1/22/2013 1:33:25 PM	Location	Interior
Equipment	Service panel	Equipment Name:	Panel 14
Ambient Air Temp:	68.0 °F	Wind Speed	0
Load (%)	No deliberate load imposed	Max Rated Load:	0
Exception Temperature:	0	Potential Problem	None
Recommended Action	No action	Repair Priority:	0
Emissivity:	0.95	Reflected Temperature:	68.0 °F
Camera Manufacturer	Fluke Thermography	Camera:	Ti32-10020374 (60Hz)

Name	Temperature	Emissivity	Background
SEP	81.7°F	0.95	68.0°F

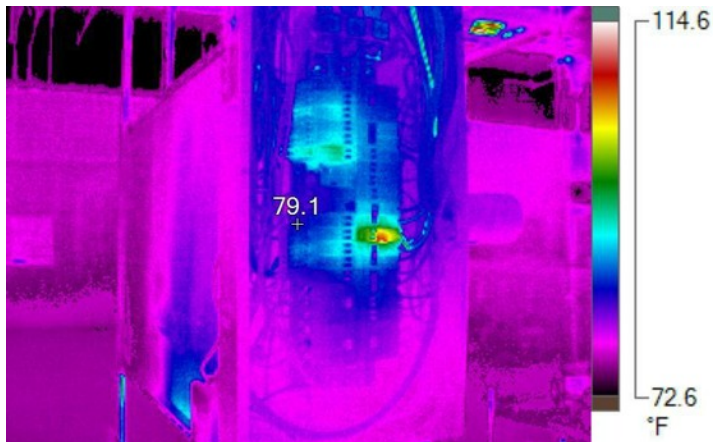
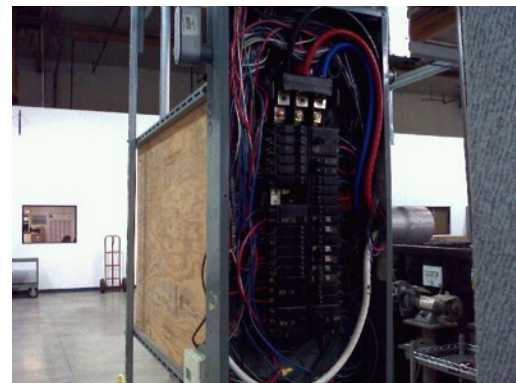
IR000674.IS2

Inspection Date:	1/22/2013 1:38:45 PM	Location	Interior mach.
Equipment	Service panel	Equipment Name:	Panel 15
Ambient Air Temp:	68.0 °F	Wind Speed	0
Load (%)	No deliberate load imposed	Max Rated Load:	0
Exception Temperature:	0	Potential Problem	None
Recommended Action	No action	Repair Priority:	0
Emissivity:	0.95	Reflected Temperature:	68.0 °F
Camera Manufacturer	Fluke Thermography	Camera:	Ti32-10020374 (60Hz)

Name	Temperature	Emissivity	Background
SEP	79.1°F	0.95	68.0°F

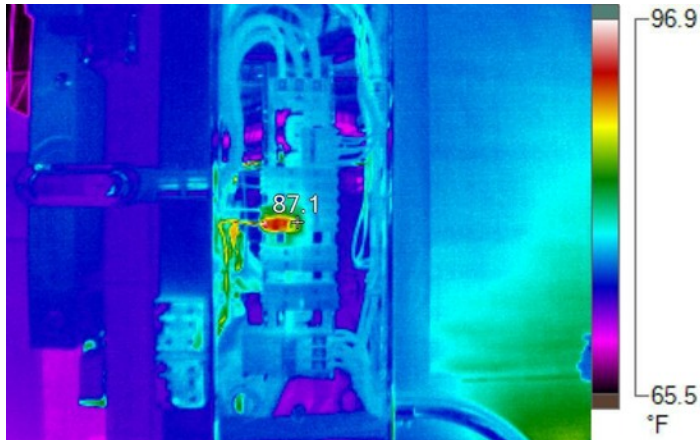
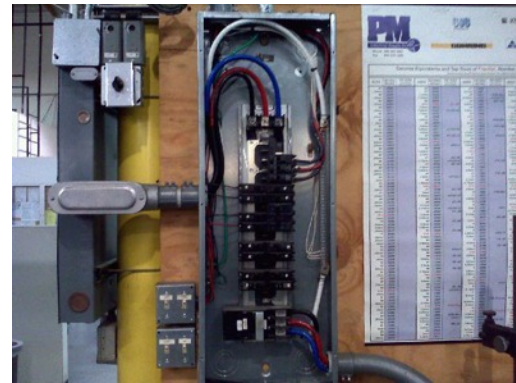
IR000676.IS2

Inspection Date:	1/22/2013 1:48:46 PM	Location	Interior mach.
Equipment	Service panel	Equipment Name:	Panel 16
Ambient Air Temp:	68.0 °F	Wind Speed	0
Load (%)	No deliberate load imposed	Max Rated Load:	0
Exception Temperature:	0	Potential Problem	None
Recommended Action	No action	Repair Priority:	0
Emissivity:	0.95	Reflected Temperature:	68.0 °F
Camera Manufacturer	Fluke Thermography	Camera:	Ti32-10020374 (60Hz)

Name	Temperature	Emissivity	Background
SEP	87.1°F	0.95	68.0°F

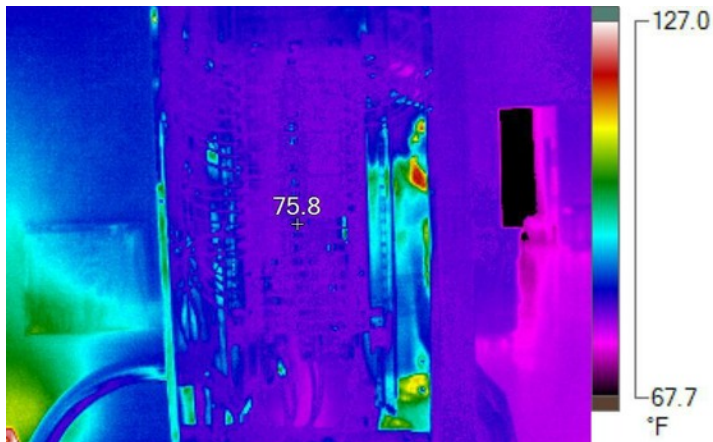
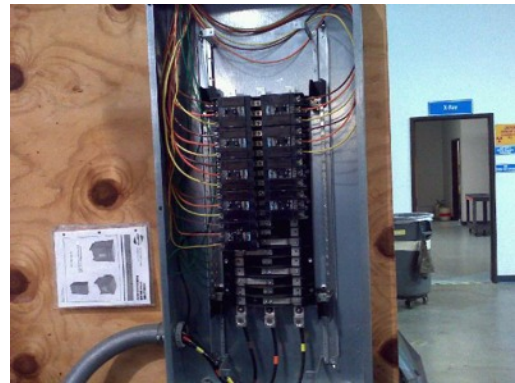
IR000678.IS2

Inspection Date:	1/22/2013 1:49:25 PM	Location	Interior Mach.
Equipment	Service panel	Equipment Name:	Panel 17
Ambient Air Temp:	68.0 °F	Wind Speed	0
Load (%)	No deliberate load imposed	Max Rated Load:	0
Exception Temperature:	0	Potential Problem	None
Recommended Action	No action	Repair Priority:	0
Emissivity:	0.95	Reflected Temperature:	68.0 °F
Camera Manufacturer	Fluke Thermography	Camera:	Ti32-10020374 (60Hz)

Name	Temperature	Emissivity	Background
SEP	75.8°F	0.95	68.0°F

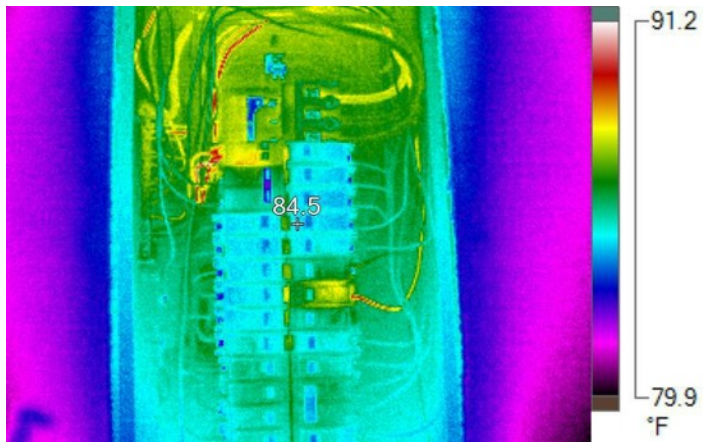
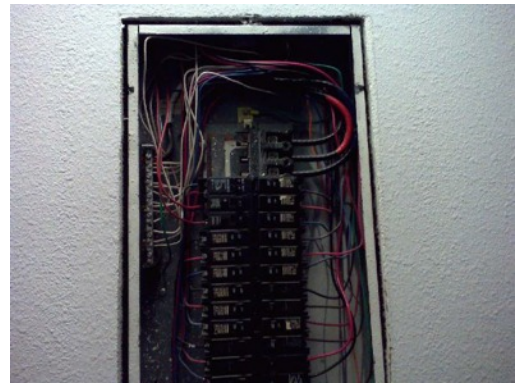
IR000679.IS2

Inspection Date:	1/22/2013 2:00:19 PM	Location	Interior office
Equipment	Service panel	Equipment Name:	Panel 18
Ambient Air Temp:	68.0 °F	Wind Speed	0
Load (%)	No deliberate load imposed	Max Rated Load:	0
Exception Temperature:	0	Potential Problem	None
Recommended Action	No action	Repair Priority:	0
Emissivity:	0.95	Reflected Temperature:	68.0 °F
Camera Manufacturer	Fluke Thermography	Camera:	Ti32-10020374 (60Hz)

Name	Temperature	Emissivity	Background
SEP	84.5°F	0.95	68.0°F

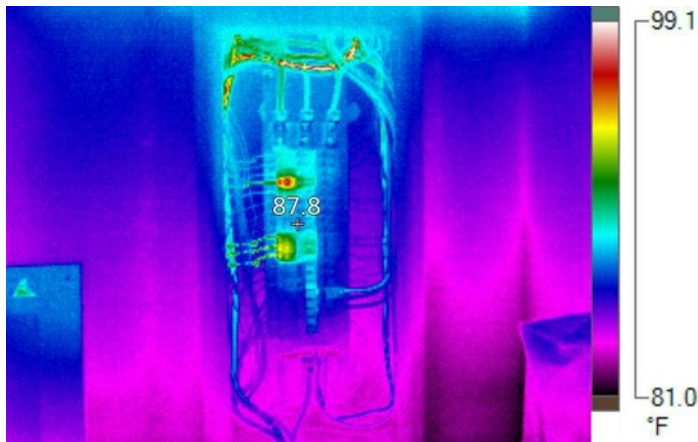
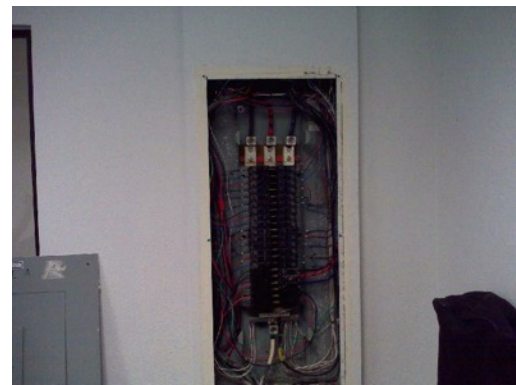
IR000680.IS2

Inspection Date:	1/22/2013 2:07:47 PM	Location	Interior office
Equipment	Service panel	Equipment Name:	Panel 19
Ambient Air Temp:	68.0 °F	Wind Speed	0
Load (%)	No deliberate load imposed	Max Rated Load:	0
Exception Temperature:	0	Potential Problem	None
Recommended Action	No action	Repair Priority:	0
Emissivity:	0.95	Reflected Temperature:	68.0 °F
Camera Manufacturer	Fluke Thermography	Camera:	Ti32-10020374 (60Hz)

Name	Temperature	Emissivity	Background
SEP	87.8°F	0.95	68.0°F
